**Flood Control Project Maintenance  
Levee Inspections**  
**LMA District Cover Sheet**  
**Spring 2017 Levee Inspection Results**

**Reclamation District No. 0501 Ryer Island**

**Spring 2017 Levee Inspection Results**

**Levee Inspection Report By Mile - Spring 2017**

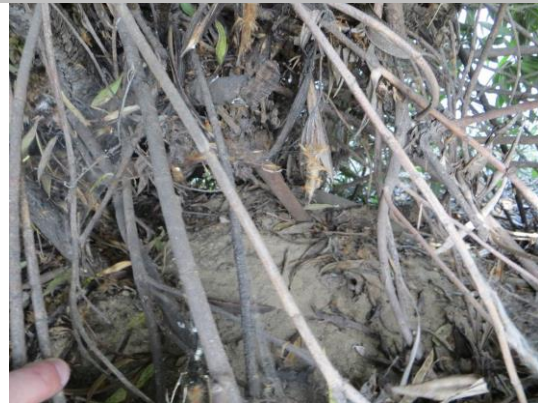
Photo 1 of 3 : UCIP\_SP\_2017\_44643\_73842.jpg

LM Start	0.70	Rating **	M	Issue No.	983
LM End	0.70	Issue Type +	En	Location *	LS
Category	Supplemental			GPS Latitude/Longitude	
				Start	End
Item	DWR UCIP Field Study			38.244726 °	38.244726 °
				-121.602900 °	-121.602900 °
DWR ID					
Comment Code					
Inspector Comment					
FS_ID:44643 DS_ID:21089 EP_NO: 2683 Repair Type: Non-Urgent Crossing Status: Indicator Found UCIP Comments: Appears abandoned and if so should be done so properly. FIELD_STRUCT_DESC: *ABANDONED* 2-inch steel water pipe and 1-inch steel electrical conduit through the levee, both 3.0 feet below the crown. Portion of pipe visible under oleanders on LS shoulder may be part of this crossing. No evidence remains on WS slope. (Permit No. 2683-1959, J. Gosner) FS Date: 4/21/2015

Pipes visible under oleander on LS shoulder.

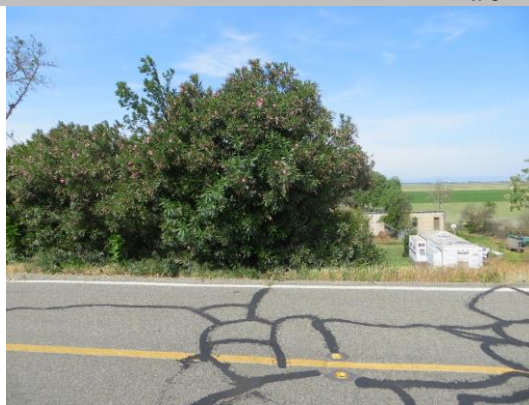
Photo 3 of 3 : UCIP\_SP\_2017\_44643\_73840.jpg

Pipes visilbe under oleander on LS shoulder.

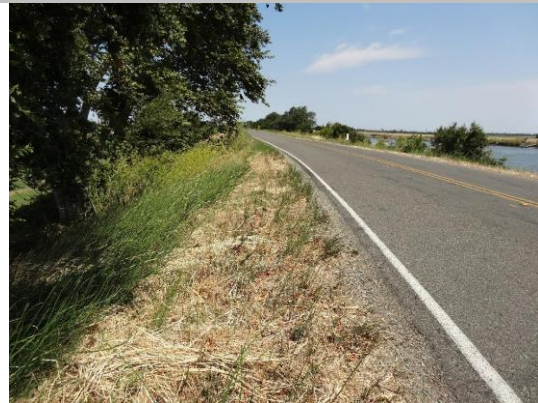
Photo 1 of 3 : UCIP\_SP\_2017\_50020\_75648.jpg

Comment Code					
Inspector Comment					
FS_ID:50020 DS_ID:21034 EP_NO: N/A Repair Type: Non-Urgent Crossing Status: Found UCIP Comments: 8/22/2016 Crossing has been downgraded from Urgent to Non-Urgent -- no evidence of damage to levee is present. Dense vegetation limits the inspector's visibility to identify signs of pipe failure (leaks) through the slope. Recommend removing vegetation along pipe alignment to conduct proper inspection of structure and appurtenances. Also will need to coordinate with owner to determine if permit was obtained for the modifications made to crossing (PVC pipe sleeved through existing pipe). (DWR UCIP - omagana)4/21/2015 Unauthorized PVC pipe. Annular space not grouted. 14-inch pipe open on both ends. (DWR UCIP - omagana) FIELD_STRUCT_DESC: 14-inch steel irrigation pipe through the levee, 3.2 feet below the crown. 10-inch polyvinyl chloride (PVC) pipe sleeved through 14-inch with a siphon breaker located on the landside (LS) shoulder. [Additional Reference(s): DWR Levee Log, 1980 and 2005. USACE Sacramento O&M Manual Unit No. 105, April 1959, (HLM 1.0)]. FS Date: 8/22/2016

View of levee crown and LS shoulder.

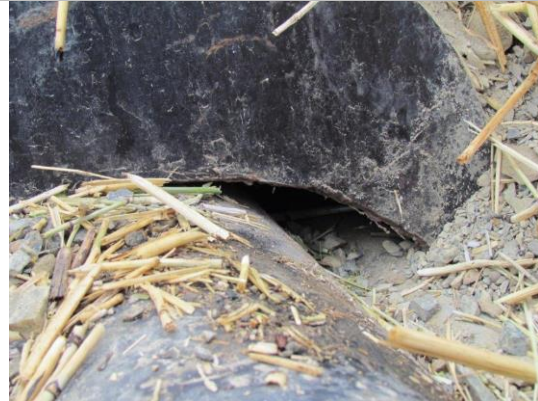
Photo 3 of 3 : UCIP\_SP\_2017\_47516\_75034.jpg

Item	DWR UCIP Field Study			38.228373 °	38.228373 °	
				-121.604120 °	-121.604120 °	
DWR ID						
Comment Code						
Inspector Comment						
FS_ID:47516 DS_ID:21086 EP_NO: 13233 Repair Type: Non-Urgent Crossing Status: Found UCIP Comments: Annular space between pipes not grouted. FPIIB Inspector Herman Phillips will contact owner regarding lack of permit for sand filters. Steel plate partially covers openings between pipes. FIELD_STRUCT_DESC: 14-inch steel pipe through the levee, 2.5-feet below the crown. Cutoff wall around pipe at center of levee. Pump and check valve in pump house on waterward slope. Service pole on landward slope. (Permit No. 13233-1982) 8-inch steel irrigation pipe sleeved through 14-inch (under Permit No. 11813-1, 2013). A 1.5 and a 2.5-inch electrical conduit at same location. Siphon breaker on both shoulders. FS Date: 4/21/2015

LS: (photo from FPIIB Inspector H. Phillips) Annular space not grouted.

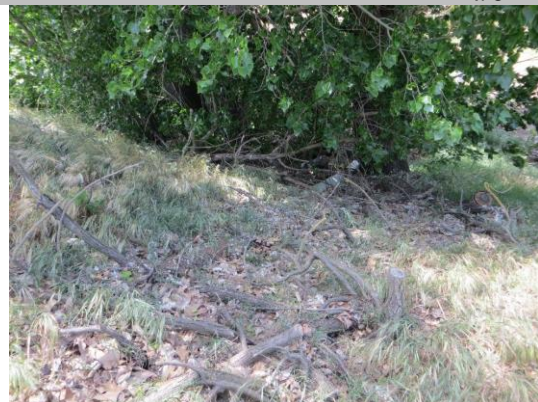
Photo 1 of 3 : UCIP\_SP\_2017\_44683\_73882.jpg

Pipe visible on LS slope.

FS\_ID:44683  
DS\_ID:21021  
EP\_NO: N/A  
Repair Type: Non-Urgent  
Crossing Status: Found  
UCIP Comments: Appears abandoned and if so should be done so properly. Discarded pipe on WS slope should be removed.  
FIELD\_STRUCT\_DESC: 10-inch steel irrigation pipe through the levee, 2.5-feet below the crown. Pump and gate valve in pump house on waterward slope. a 4'X4' concrete distribution box, power pole, and meter on LS toe (USACE-1959). This entry matches the Drainage or Irrigation Structure referenced in O&M manual (HLM 2.50).  
FS Date: 4/21/2015

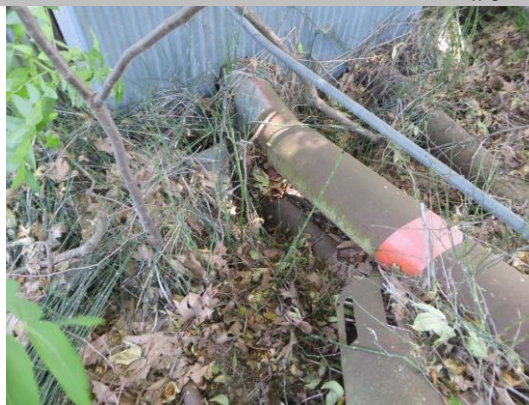
Photo 3 of 3 : UCIP\_SP\_2017\_44683\_73880.jpg

Pipe, conduit, and pipe debris on WS slope.

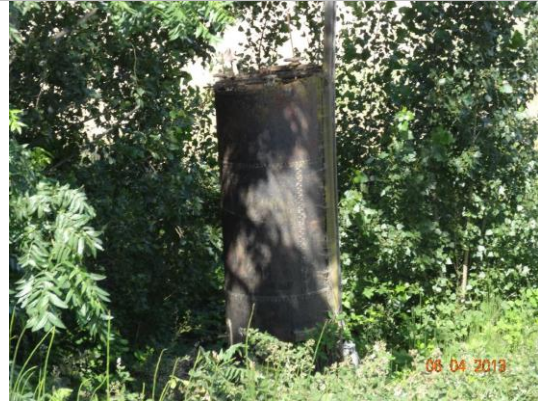
Photo 3 of 3 : UCIP\_SP\_2017\_32526\_58934.jpg

UCIP Comments: Dense vegetation limits the inspector's visibility to identify signs of pipe failure (leaks) through the levee slopes. Recommend removing vegetation along pipe alignment to conduct proper inspection of structure and appurtenances. Additional notes: pump was running during inspection, 16-inch pipe debris section located on landward side, view of standpipe and support structure on waterward side does not match structure description--need to determine if crossing has been altered.

Standpipe on landward toe.

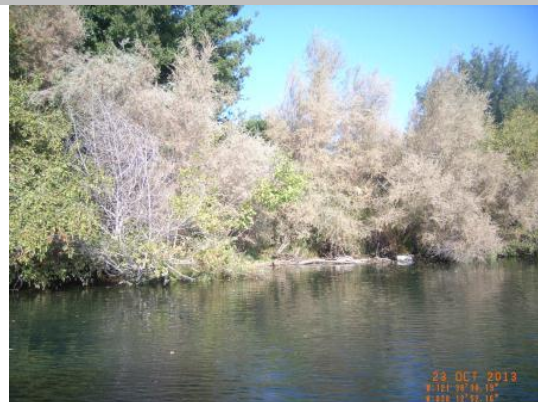
Photo 1 of 1 : SP\_2017\_RD0501\_169\_3\_20170404\_00003.jpg

LM Start	2.85	Rating **	M	Issue No.	3
LM End	2.91	Issue Type +	Ma	Location *	WS
Category	Supplemental			GPS Latitude/Longitude	
				Start	End
Item	2015 USACE Erosion Survey, DRAFT			38.214838 °	38.214075 °
				-121.608129 °	-121.608750 °
DWR ID	DWR_RD0501_01_f_2016_3				
Comment Code					
Inspector Comment					
2009 - Rock is starting to unravel, probably from a tree pop-out, hard toe. 2015: No observed changes. [2015 Site ID: STM_18-9_R]

USACE 2013 Photo #1

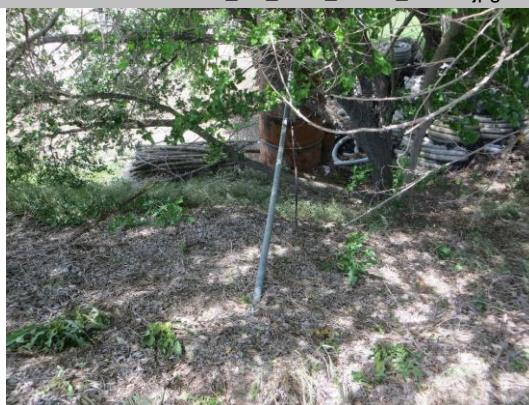
Photo 1 of 2 : UCIP\_SP\_2017\_44688\_73891.jpg

LM Start	2.97	Rating **	M	Issue No.	988
LM End	2.97	Issue Type +	En	Location *	LS
Category	Supplemental			GPS Latitude/Longitude	
				Start	End
Item	DWR UCIP Field Study			38.213439 °	38.213439 °
				-121.609583 °	-121.609583 °
DWR ID					
Comment Code					
Inspector Comment					
FS_ID:44688					
DS_ID:21025					
EP_NO: N/A					
Repair Type: Non-Urgent					
Crossing Status: Found					
UCIP Comments: Pipe appears abandoned and if so should be done so properly.					
FIELD_STRUCT_DESC: 2-inch galvanized iron irrigation pipe through the levee, 3.2 feet below the crown. 6-foot diameter steel standpipe at LS toe. Pipe may run parallel to levee crown to cross levee at site of 14-inch HLM: 2.98					
FS Date: 4/21/2015

Pipe visible at LS shoulder. Pipe connects to top of steel standpipe at LS toe.

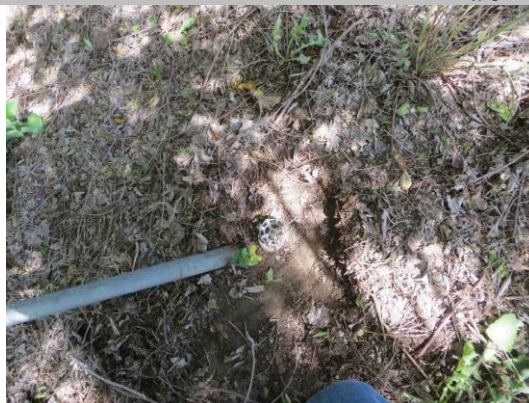
Photo 2 of 2 : UCIP\_SP\_2017\_44688\_73890.jpg

Shutoff valve at LS shoulder.

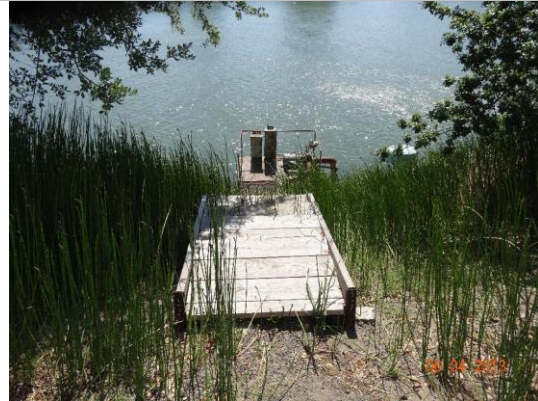
Photo 2 of 3 : UCIP\_SP\_2017\_50022\_58940.jpg

UCIP Comments: 8/22/2016 Same as last inspection (pipe appears to be leaking on WS). UPDATES--levee crown has been re-paved by Sacramento County--no cracks found on crown surface. Dense vegetation limits the inspector's visibility to identify signs of pipe failure (leaks) through the slope. Need to contact owner to determine status of crossing. Due to the leak on the WS it is recommended that the pipe be tested for internal integrity through the levee. (DWR UCIP - omagana)6/04/2013 Damage present to pipe (leak). Additional notes available: 8-inch is leaking on landward side--white sealant and rag used to seal hole, single line crack on the crown of the alignment, pipe through the levee could be bigger than 8-inch unable to confirm. Also found a 3-inch steel pipe approximately 7 feet upstream from 8-inch pipe (authorized or unauthorized?). Need to contact owner to coordinate with CVFPB. (DWR UCIP - omagana)

Station details--gate valve, air vent, and other appurtenances.

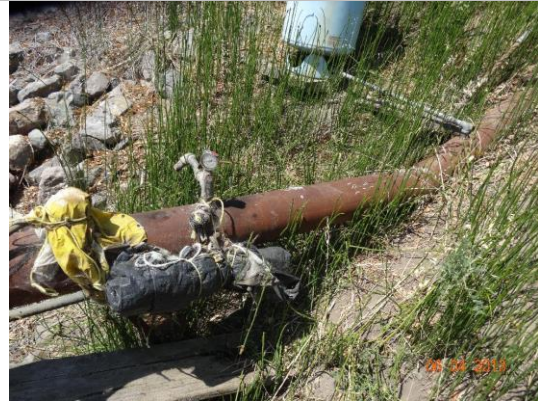
Photo 3 of 3 : UCIP\_SP\_2017\_50022\_58945.jpg

View of waterward side--pressure gauge, conduit, and wraps to prevent leaks.

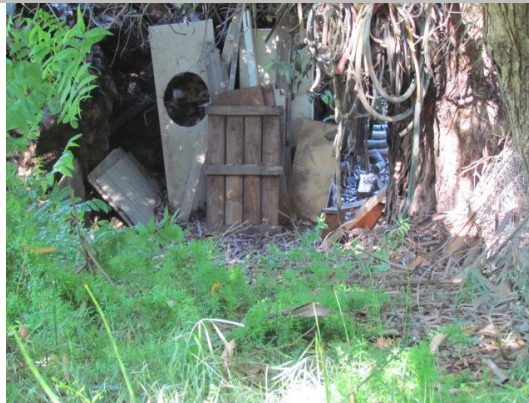
Photo 2 of 2 : SP\_2017\_RD0501\_169\_63\_20170522\_00061.jpg

RD 501 Levee mile 3.24 landside toe.

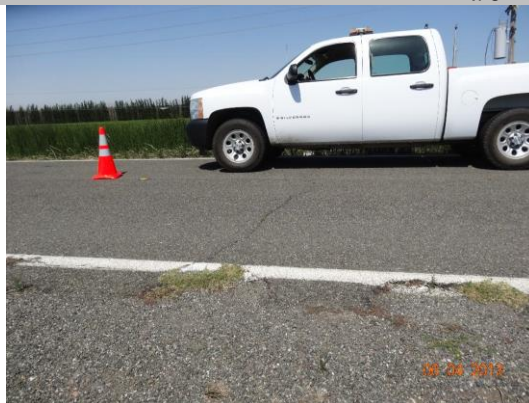
Photo 1 of 3 : UCIP\_SP\_2017\_32529\_58954.jpg

Single line crack on crown.

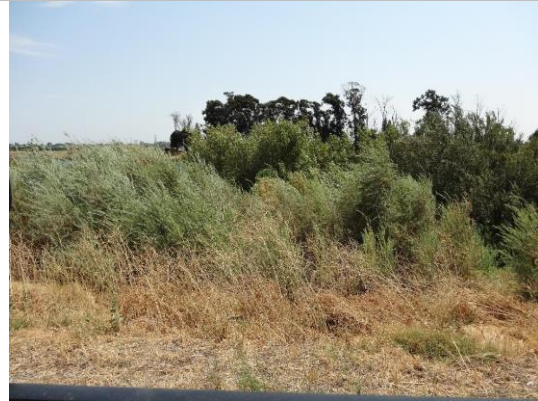
Photo 3 of 3 : UCIP\_SP\_2017\_50024\_75655.jpg

Dense vegetation on WS--unable to locate line.

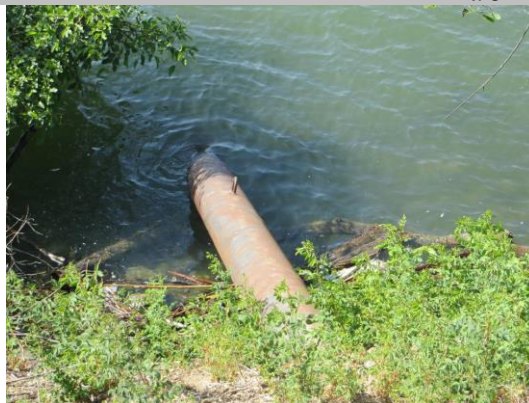
Photo 3 of 3 : UCIP\_SP\_2017\_44726\_73920.jpg

Pipe visible on WS toe.

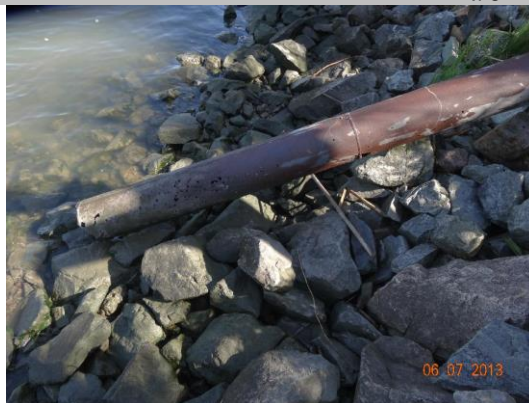
Photo 3 of 3 : UCIP\_SP\_2017\_50018\_58966.jpg

Deteriorated pipe with visible holes through pipe wall.

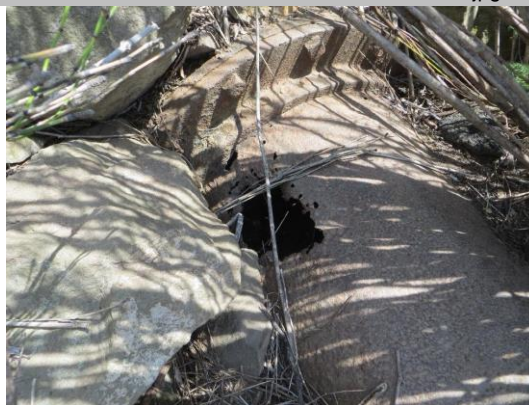
Photo 2 of 3 : UCIP\_SP\_2017\_44753\_73954.jpg

Hole in pipe at WS toe.

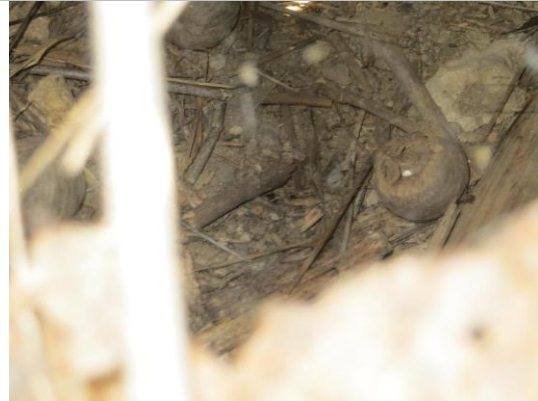
Photo 3 of 3 : UCIP\_SP\_2017\_44753\_73953.jpg

Inside hole in pipe at WS toe.

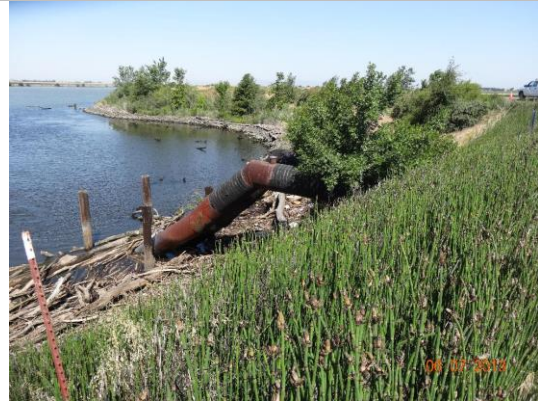
Photo 3 of 3 : UCIP\_SP\_2017\_47049\_33374.jpg

View of exposed pipe section on waterward side.

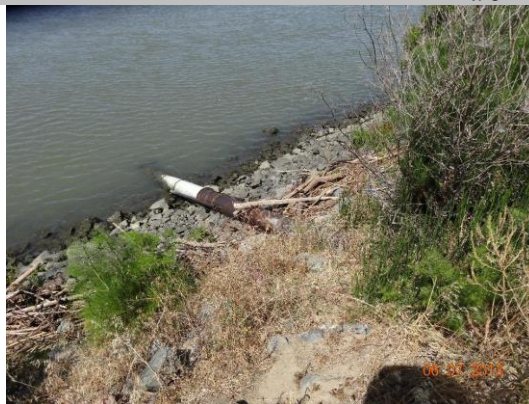
Photo 3 of 3 : UCIP\_SP\_2017\_32537\_58988.jpg

View of exposed section of pipe at waterward toe.

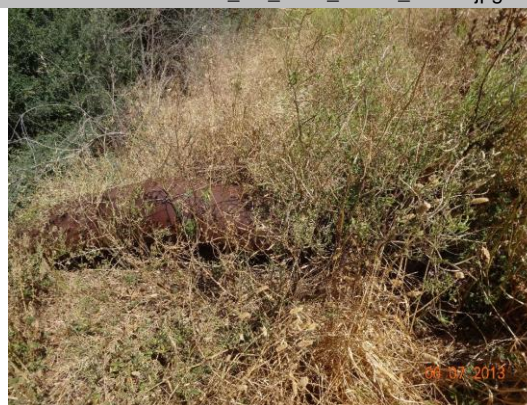
Photo 2 of 3 : UCIP\_SP\_2017\_19657\_33400.jpg

Dense vegetation along the upper portion of the waterward slope prevents proper inspection of crossing.

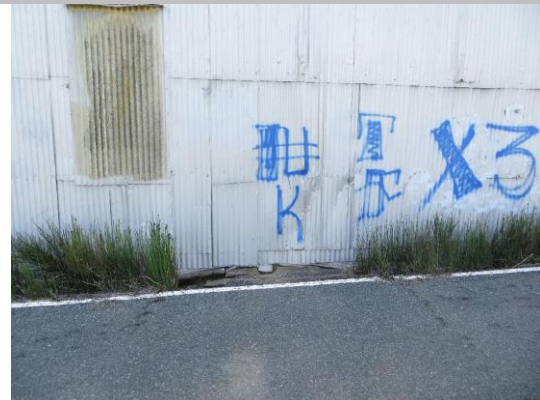
Photo 1 of 3 : UCIP\_SP\_2017\_50023\_73942.jpg

Building on LS shoulder prevents access to LS of levee.

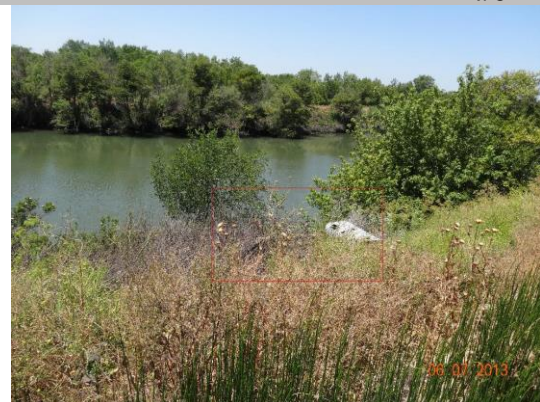
Photo 1 of 3 : UCIP\_SP\_2017\_43524\_33425.jpg

View of waterward side. Dense vegetation limits inspections. Signs of structure visible highlighted by red box.

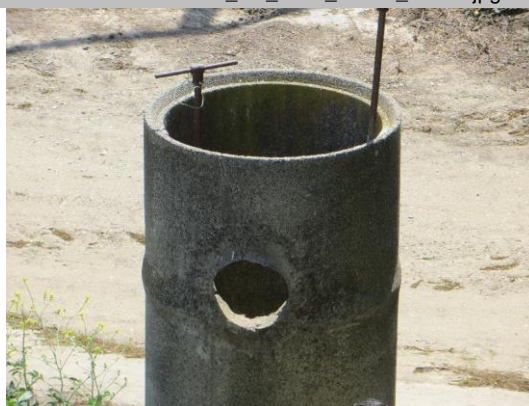
Photo 2 of 2 : UCIP\_SP\_2017\_44746\_73943.jpg

10-inch diameter hole cut in side of standpipe where pipe once was installed.

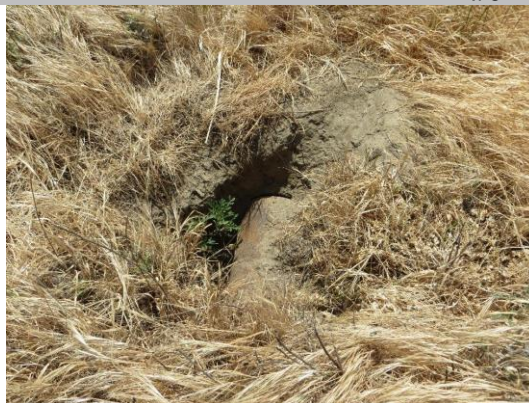
Photo 2 of 2 : UCIP\_SP\_2017\_44877\_73945.jpg

Cut in buried pipe on LS shoulder.

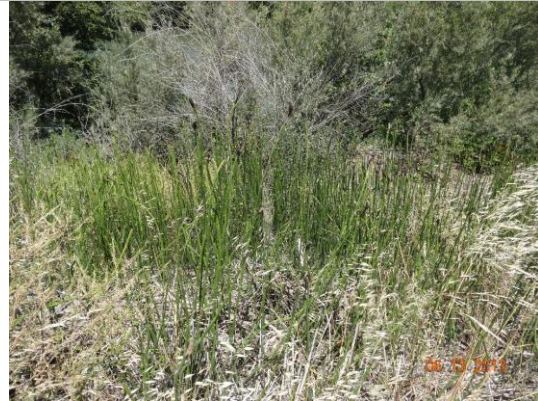
Photo 3 of 3 : UCIP\_SP\_2017\_32543\_59026.jpg

View of waterward side. Dense vegetation along levee slope.

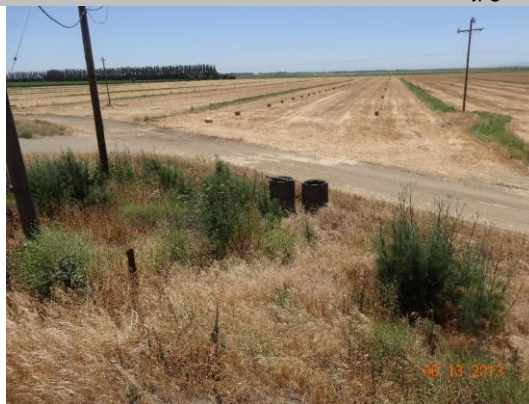
Photo 3 of 3 : UCIP\_SP\_2017\_32544\_59036.jpg

Dry vegetation throughout the landward slope.

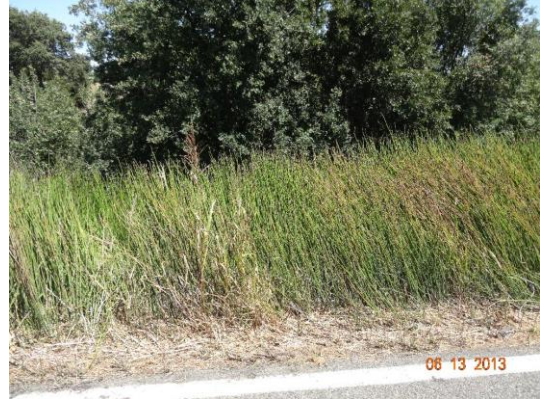
Photo 3 of 3 : UCIP\_SP\_2017\_50021\_59064.jpg

High vegetation along waterward side.

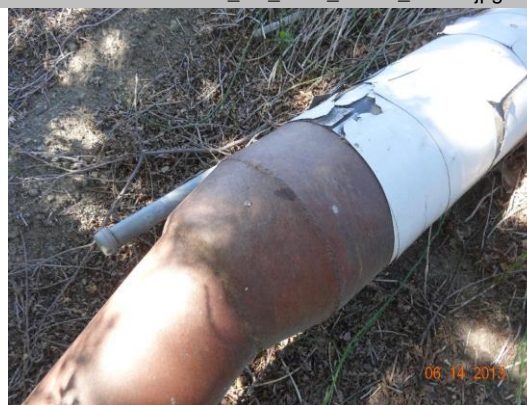
Photo 2 of 3 : UCIP\_SP\_2017\_44471\_33495.jpg

Pipe section reduced at the waterward side daylight.
